3D Marine Seismic Survey

ACCOBAMS MMO & PAM Report
Marine Seismic Survey
EPI Report No. E1118

FINAL REPORT

MISSION AT SEA FROM 14 DECEMBER 2022 TO 07 JANUARY 2023
TYPE OF MISSION: 3D MARINE SEISMIC SURVEY

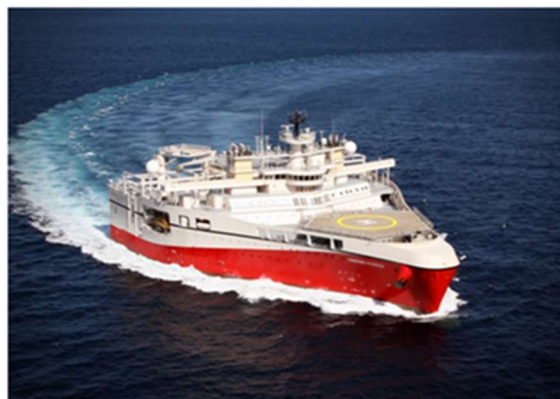
Figure 2 Ramform Hyperion

CALL SIGN	C6DB4
TYPE	SEISMIC Vessel
LENGTH	104.2m
BREADTH	70m
DRAFT	6.9 m (max)
GRT	20 637 t

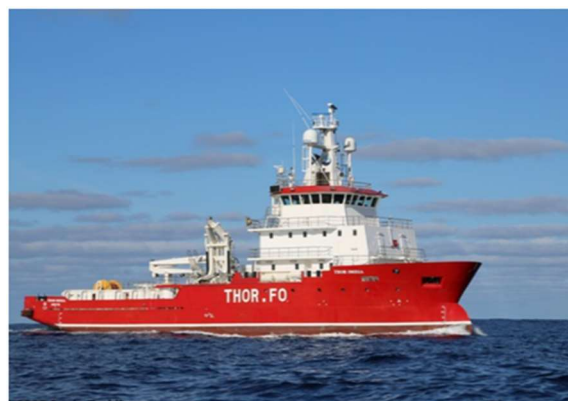
Figure 3 Thor Omega

CALL SIGN	OZ2065
TYPE	SUPPORT VESSEL
LENGTH	55.10m
BREADTH	12.5m
DRAFT	4.85m
GRT	1153t

The seismic survey was undertaken from seismic vessel *Ramform Hyperion* (Figure 2), which was assisted by three support and chase vessels, the *Thor Omega* (main support), the *Vernicos Sifnos* and the *EDT Zenon* (Figures 3 and 4).

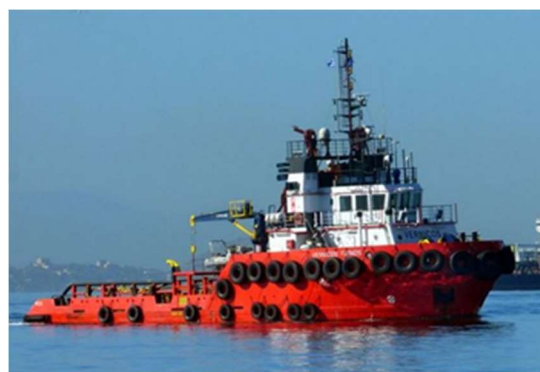
Figure 4 Vernicos Sifnos

CALL SIGN	SVA7860
TYPE	SUPPORT VESSEL
LENGTH	38m
BREADTH	11.8m
DRAFT	5m
GRT	499t

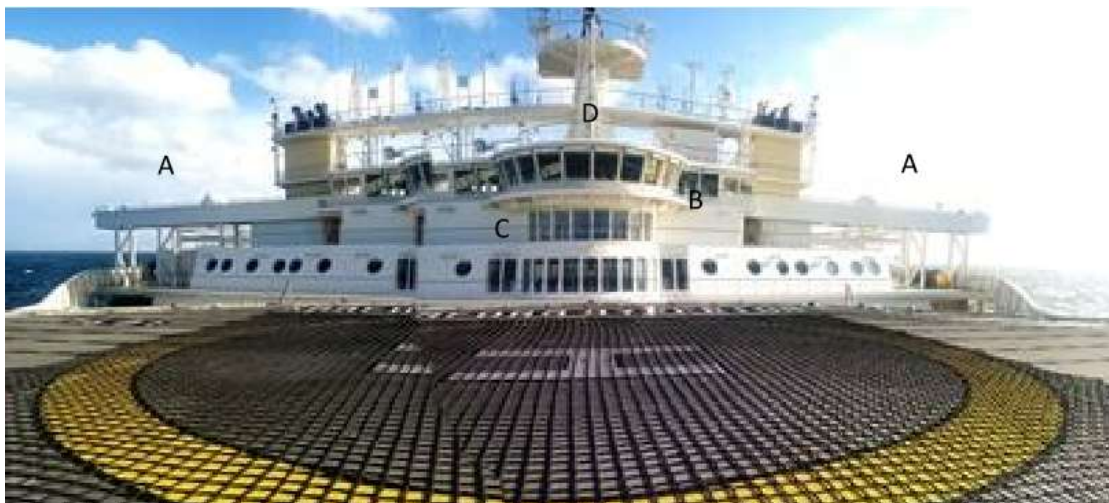
Figure 7 Observation Platforms.

The main platform of observation was located on the bridge, bridge-wings and monkey deck, which allowed 360-degrees of visibility at 20.27 m and 23.17 m elevation above sea level respectively. A front view lounge also available where the MMO station was located at 17.52 m high (Table 7 and Figures 7 and 8).

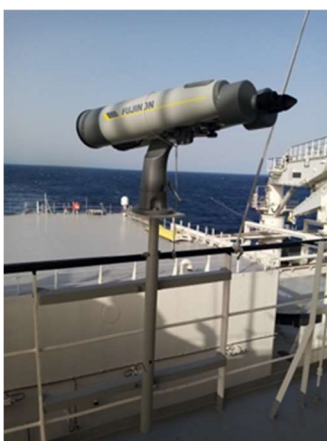
Figure 8 Long distances binoculars on 'Monkey Deck'

PLATFORM	HIGH (m)	VISIBILITY
Deck Wings (A)	20.27	360°
Bridge (B)	20.27	360°
Front View Lounge (C)	17.52	180°
Monkey Deck (D)	23.17	360°

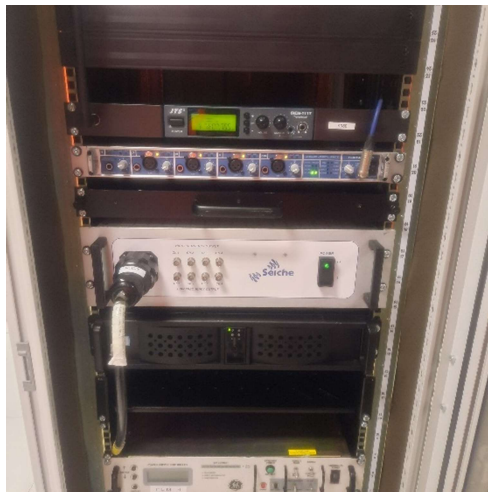
Figure 9 PAM electronics

Buffer box circuitry splits each hydrophone input into low frequency (LF) and high frequency (HF) band outputs. All four (4) LF channels are input to an RME Fireface 800 sound card. In standard configuration, two (2) channels (H1, H2) are digitized at 48 kHz, 24bit. The Fireface is connected to PC via a firewire 800 cable. RME software allows the PAM operator to control which hydrophone signals are monitored over headphones. The headphone mix typically consists of either the raw hydrophone signals or the processed playback signals from the PC. The playback output is subject to a veto (PAMGuard software module) that removes the sound of the airgun shots ('seismic veto'). The HF output of the buffer box is digitized at the buffer box by the National Instruments data acquisition card at 500 kHz, 16 bit (H3, H4) and sent to the PC via USB. The PC was custom-built by Seiche and runs on Microsoft Windows 10 64 bit.

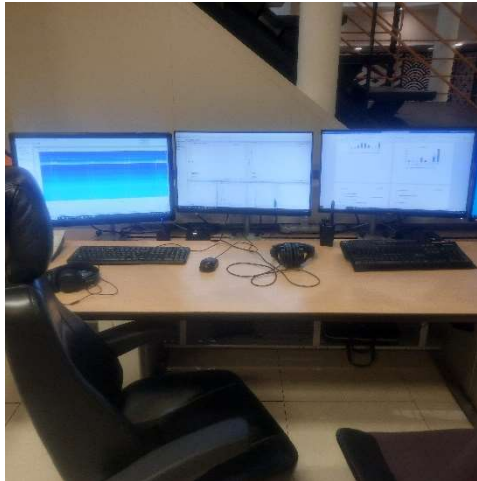
Figure 10: Local monitoring station

The Local Monitoring Station (LMS) was set-up in the common area close to the instrument room (Figure 10). The LMS consisted of a mini 'net-top' PC, two wide-screen display monitors and a pair of headphones. A remote desktop connection to the base station was patched through from the rack room. The software NetSupport Manager is used to control the base station systems. A stereo audio stream was broadcast from the Fireface sound card over the local area network connection to the LMS. The audio stream consists of either the H1+H2 hydrophone signals, H3+H4, or the Veto playback channels, as selected by the PAM operator. An Unreal software suite is used to control the audio broadcast (Unreal Live Server, Media Server and Media Player).

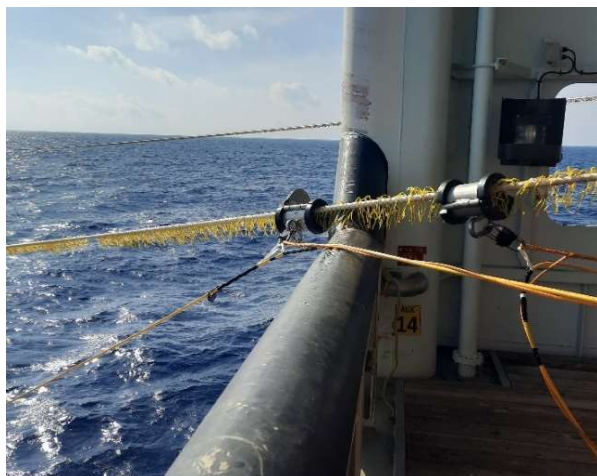
Figure 11. Slide collar over the lead-in (during deployment)

Both sliding collars and all four (4) quick-links were submerged after deployment. A chain weight of 3 kg was attached with tape to the PAM cable at 15 m distance from hydrophone array. The depth of the hydrophone array was between 20 – 30 meters approximately during the survey, with variability depending on the vessel speed. The cable was loaded onto a mechanical winch, which was utilized to facilitate cable deployment and retrieval.

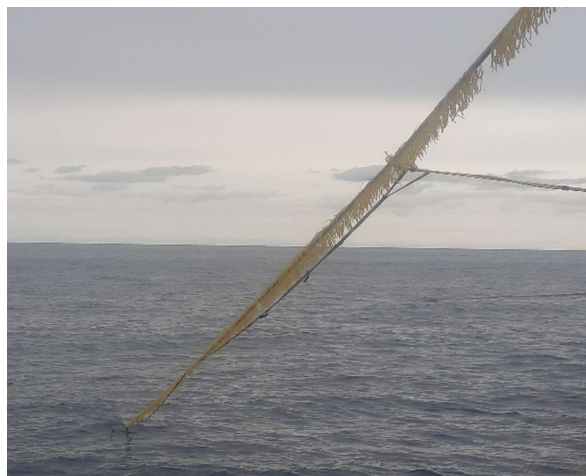
Figure 12. Cable deployed on lead-in 12.

The PAM tow cable was deployed and recovered to spur-line winches, once the seismic streamers and paravanes had been fully deployed. The end of the cable was connected to the deck cable that was installed between the streamer deck and the rack room when *Ramform Hyperion* was rigged.

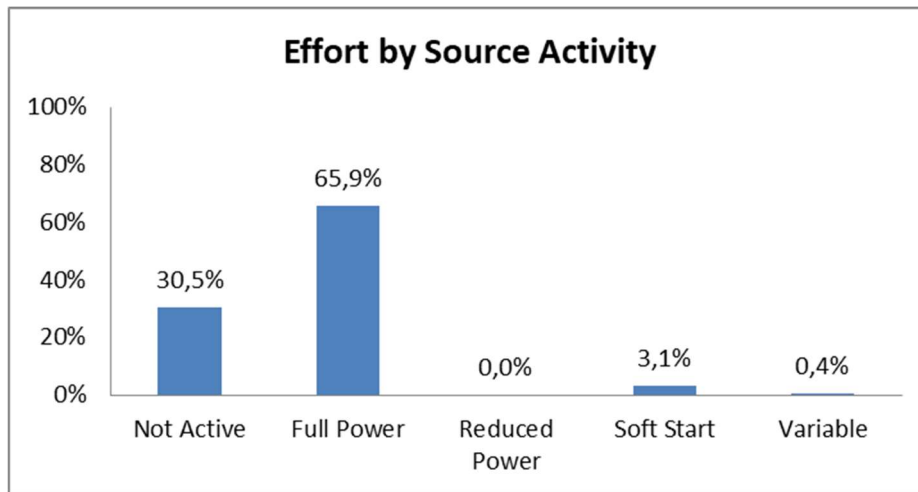
Figure 15 Time in hh:mm of visual and acoustic effort by source activity.

A total of 551:45 hours of dedicated marine mammal watches were carried out by the MMOs; 243:25 (hh:mm) took place during daytime and 308:20 (hh:mm) were during the night. 548:19 hours of dedicated marine mammal acoustic monitoring were carried out by the PAM operator from 14 December 2022 to 6 January 2023. Out of the total 1100:04 (hh:mm) of monitoring effort, 764:09 (hh:mm) (69.5%) were completed while the acoustic sources were active and 335:55 (hh:mm) (30.5%) were completed while the acoustic sources were silent (Figure 15).

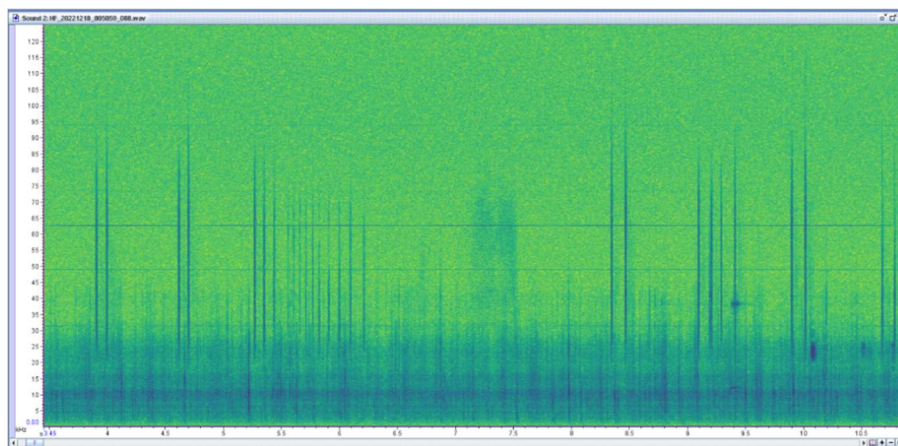
Figure 20: AD#500 Burst and HF echolocation clicks (Raven)

Acoustic Detection AD#500: On 18 December 2022, an unidentified dolphin was detected at 00:51 UTC until 00:57 UTC during pre-watch while sources were inactive. The signal started with HF (25-80kHz) burst pulses and HF click trains up to 150kHz displaying a peak amplitude of 148 dB re 1 μ Pa. Based on the strength of the signal, the animal was inside of the mitigation zone. The sighting ended during the pre-watch and the 30-minute mitigation action was completed as well within the regular pre-watch time so there was no mitigation action needed.

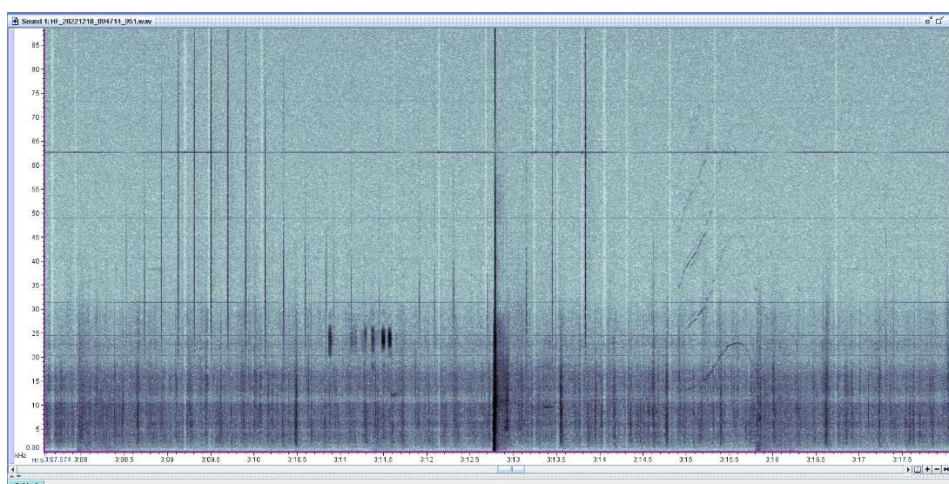
Figure 21: AD#501 Click train and whistles with harmonics of unidentified dolphin species (Audacity).

Acoustic Detection AD#501: On the 18 December 2022 at 9:50 UTC, whistles of an unidentified dolphin species (Delphinidae) were detected on the broadband spectrogram from 10 to 21 kHz frequency, showing up and down sweep with harmonics and a click train associated. No location on PAMGuard map was possible, but a clear signal suggested the dolphins were within the exclusion zone, which was confirmed visually by the MMOs.

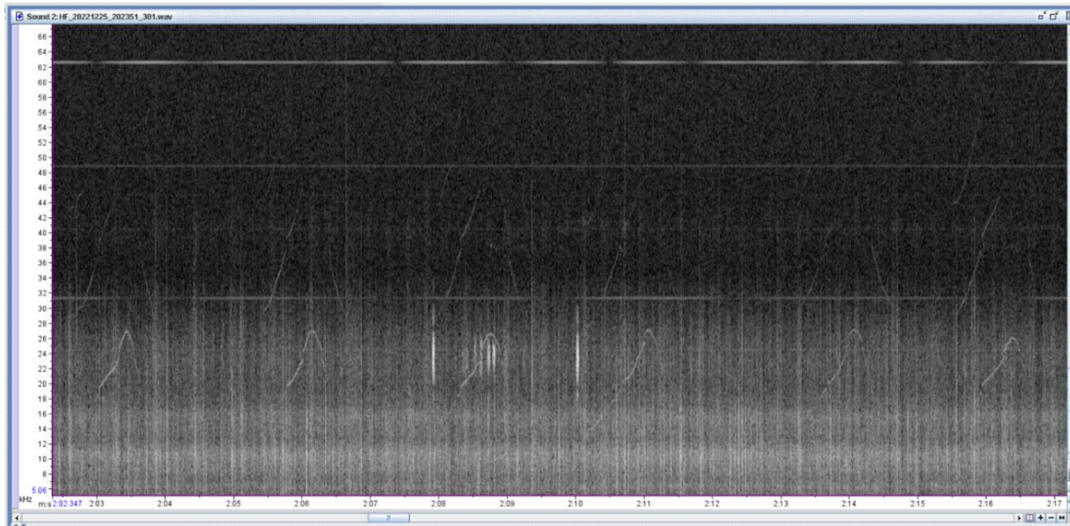
Figure 22: AD#502 unidentified dolphin's whistles with harmonics (Raven)

Acoustic Detection AD#502: On the 25 December 2022 at 20:24 UTC, an unidentified dolphin was detected on the spectrogram, whistles contours of 15 to 27 kHz frequency, upsweep with inflections and harmonics reaching more than 60 kHz. Echolocation clicks were shown in the HF spectrogram and HF click detector with a peak frequency of 140 kHz. Based on the strength of the signal, the animal was located inside of the exclusion zone, however no mitigation action was required as the detection took place while the sources were inactive and before the pre-watch started. The last signal was shown on PAMguard at 20:31 UTC.

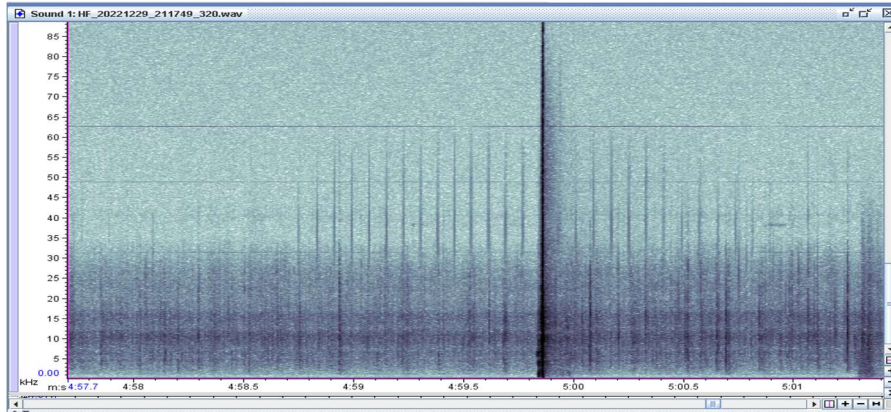
Figure 23: AD#503 toothed whale's echolocation click trains (Raven)

Acoustic Detection AD#503: On the 29 December 2022 at 21:17 UTC and 21:23 UTC, for a few seconds each time, there were echolocation click trains identified on the HF click detector, with a range of frequency of 25 to 63 kHz and an amplitude of 130dB and a fairly constant ICI. The characteristics of the click trains were typical of odontocetes. The sources were on full power but since the signal wasn't located in the map, there was no mitigation action required as per protocol.

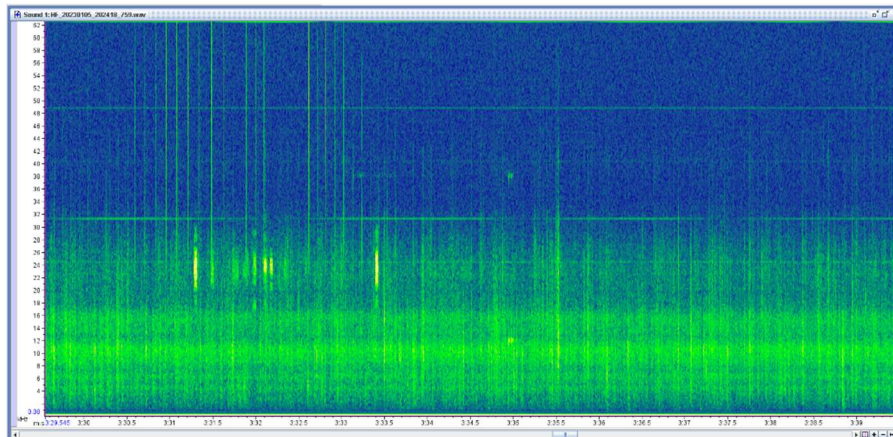
Figure 24: Acoustic Detection #504. Echolocation click train (Raven)

Acoustic Detection #504: At 20:24 UTC and until 20:42 UTC, there were intermittent echolocation click trains identified on the HF click detector with a range of frequency of 22 to 75 kHz and a mean amplitude of 130 dB and a fairly constant ICI. The characteristics of the click trains were typical of odontocetes. The sources were inactive during pre-watch when the detection started and active in soft-start when the detection ended, but based on the signal strength, the detection was located outside of the exclusion zone, so there was no mitigation action required as per protocol.
