# 2D Marine Seismic Survey

ACCOBAMS MMO and PAM Report  
Marine Seismic Survey  
EPI Report No. E0479

Client	Hellenic Petroleum Kyparissiakos Gulf Exploration and Production of Hydrocarbons Single Member S.A
Area	Kyparissiakos Gulf
Survey	Block 10
Regulatory Reference	56786/3725
Dates	20 <sup>th</sup> January to 4 <sup>th</sup> February 2022
Contractor	Shearwater Geoservices
Vessel	SW Cook
Marine Fauna Observers & Passive Acoustic Monitors	Patrick Lyne, Manuel Garcia Sandra Villar, Amber Beerman

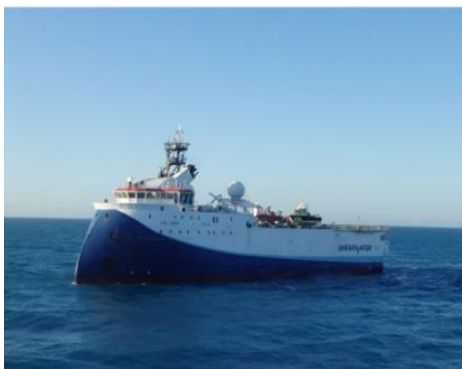
Figure 2 SW Cook (Credit: marinetransport.com)

<b>CALL SIGN</b>	5BPC2
<b>TYPE</b>	2D SEISMIC Vessel
<b>LENGTH</b>	88.80 m
<b>BEAM</b>	19 m
<b>DRAFT</b>	6.6 m (max)
<b>GR</b>	6599 tons

The seismic survey was undertaken from seismic vessel SW Cook (Figure 2), which was assisted by two chase/support vessels EDT Argonaut (Figure 3), until 26th January, and then replaced by the Platytera (Figure 4).

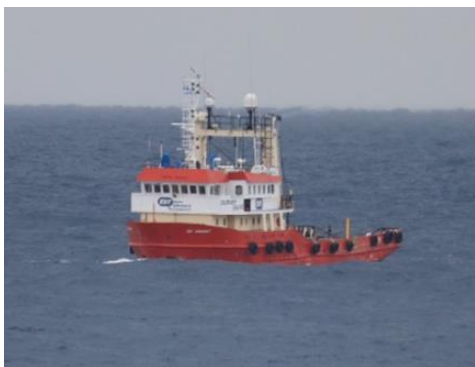
Figure 3 EDT Argonaut (Credit: Patrick Lyne)

<b>CALL SIGN</b>	P3ES7
<b>TYPE</b>	SUPPORT Vessel
<b>LENGTH</b>	41.65 m
<b>BEAM</b>	9.20 m
<b>DRAFT</b>	3.67 m (max)
<b>GR</b>	387 tons

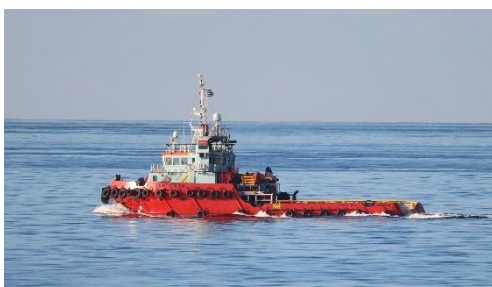
Figure 4 Platytera (Credit: Patrick Lyne)

<b>CALL SIGN</b>	SVA7933
<b>TYPE</b>	TUG Vessel
<b>LENGTH</b>	40 m
<b>BEAM</b>	11.8 m
<b>DRAFT</b>	3.80 m (max)
<b>GR</b>	499 tons

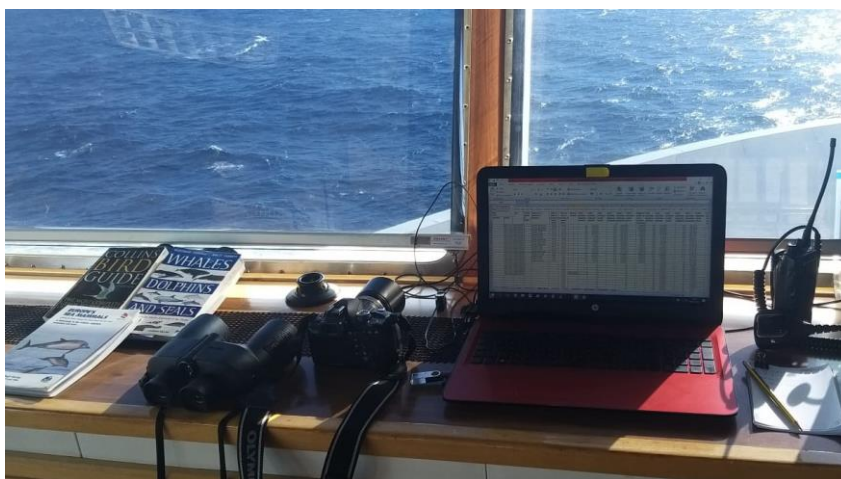
*Figure 6 MFO monitoring station on the bridge of the SW Cook (Credit: MFO/PAM Team)*

The main platform of observation was on the bridge, which allowed 360 degrees of visibility at 14.5 m elevation above sea level, and where the MFO station was located (Figure 6).

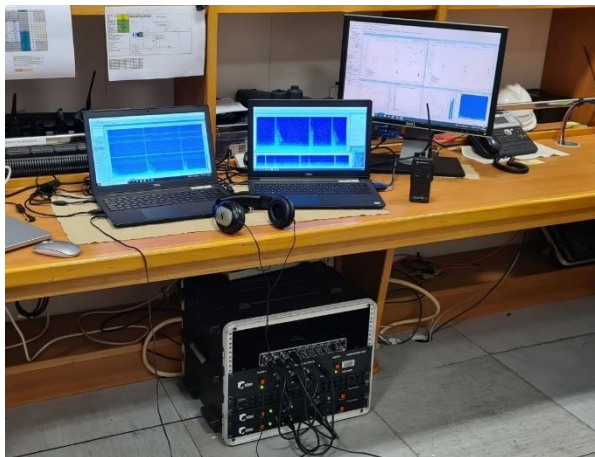
*Figure 7 PAM monitoring station in the instrument room of the SW Cook (Credit: MFO/PAM Team)*

During the survey, experienced PAM Operators maintained a PAM watch 24 hours, in accordance with recommendations in the ACCOBAMS Guidelines and the requirements stipulated within the EAP. The PAM monitoring station was located within the instrument room, allowing ease of communication with the seismic observers (Figure 7).

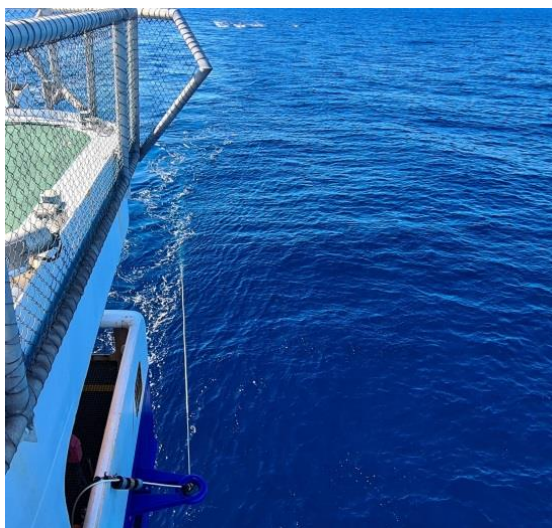
Figure 10 PAM hydrophone array cable deployment (Credit: MFO/PAM Team)

During airgun maintenance, when the array 1 and 2 were retrieved, the PAM cable deployment was shortened to 70 m to avoid entanglement and shortened to 50 m for a brief period to allow the airgun string to pass for five (5) to 10 minutes. When airgun string 3 needed repair or maintenance it was impossible to maintain a PAM watch as the noise on the gun string meant detection was completely impossible when the deployment was shortened to 30 m. This meant that the pre-watch of two (2) hours could only be commenced once the array had been deployed again, and the PAM cable was then redeployed to the full 150 m. Once airguns were redeployed the PAM deployment was returned to 150 m.

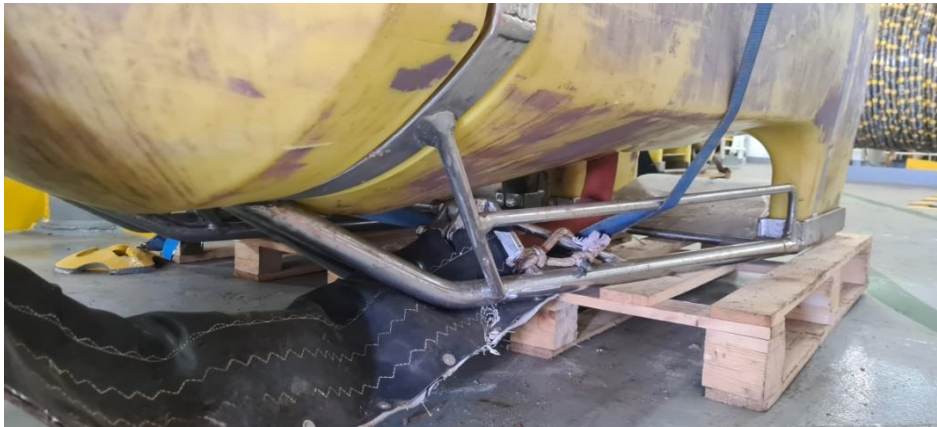
Figure 20 Turtle guard SW Cook (Credit: MFO/PAM Team)

**TURTLE GUARD.** Due to presence of sea turtles in the survey area, a turtle protection system (Turtle Guard) should be installed on the towed equipment to prevent any accidents.
